SAND98-2702

Posttest Metallurgical Evaluation Results for Steel Containment Vessel (SCV) High Pressure Test

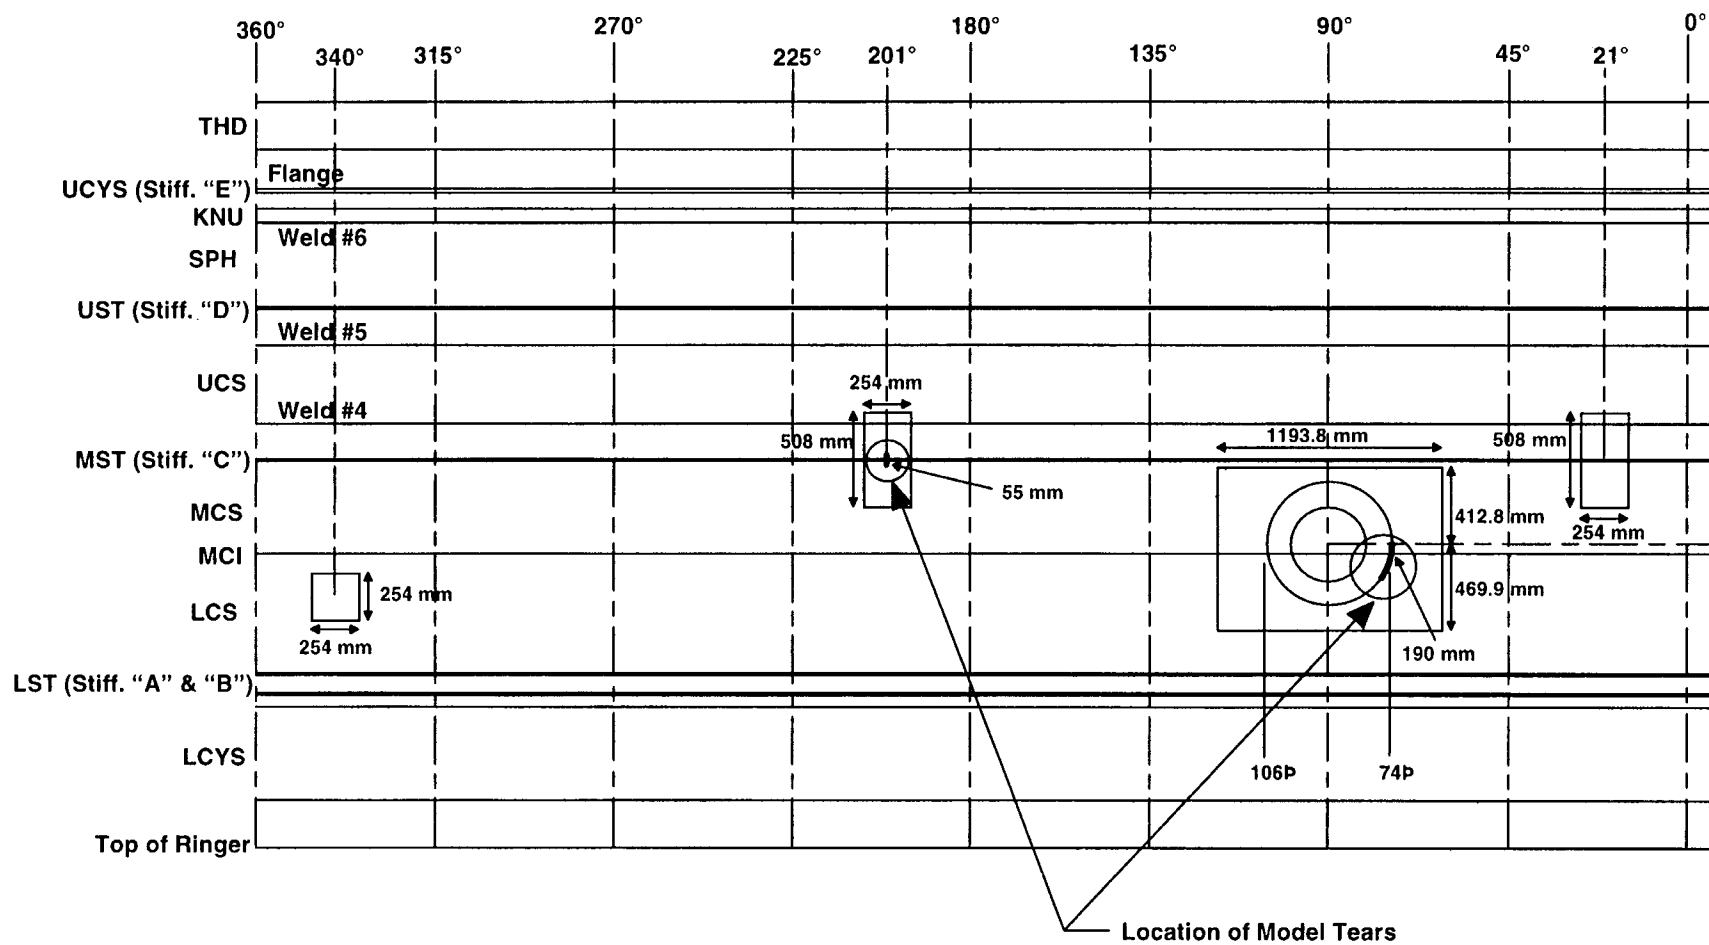
Figure 2-2. Elevation view of SCV model wall showing sampling locations.

Three types of localized damage regions were observed on the model. These are discussed in detail in following sections of this report. Damage locations and approximate sizes of sections cut from the model are given in Figure 2-2.

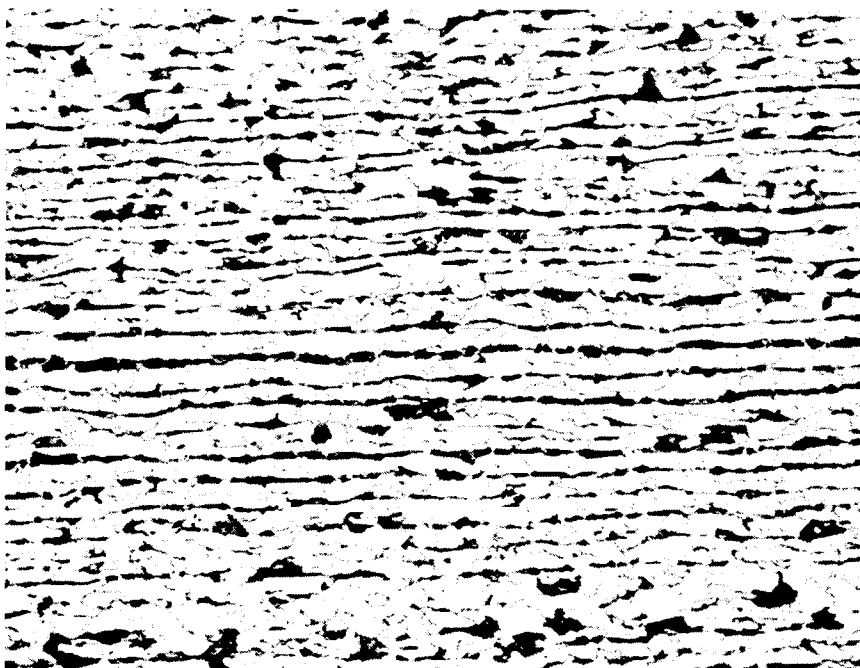
This alloy’s base metal microstructure was found to consist of a heavily banded ferrite and pearlite (Figure 4-1). This is typical of hot-rolled carbon steel. Its hardness was found to be 89.2 Rockwell B, suggesting an UTS of ~610 MPa (*ASM Metals Handbook*, 1967). Average hardness measurements are given in Table 4-2; a complete listing of all hardness values is given in Appendix B. This is ~10% higher than the reported UTS of 560 MPa, indicating that this material experienced net section yielding and a small amount of plastic deformation strain hardening during testing of the model. No undeformed material was available for hardness testing, since the SCV model experienced plastic deformation.

Figure 4-1. Banded ferrite and pearlite microstructure typical of SGV480 base metal, 400 \times .

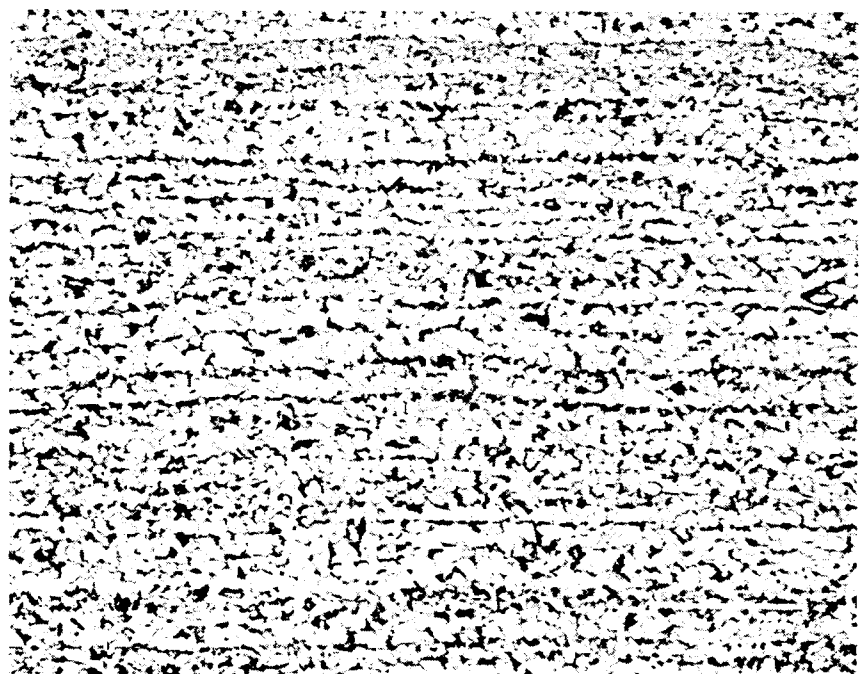
When welded, the reaustenitized heat affected zone (HAZ) transformed mostly to a ferrite and pearlite microstructure similar to, but somewhat finer than the base metal (Figure 4-2). Some

Figure 4-2. Banded ferrite and pearlite microstructure typical of SGV480 heat affected zone, 400 \times .

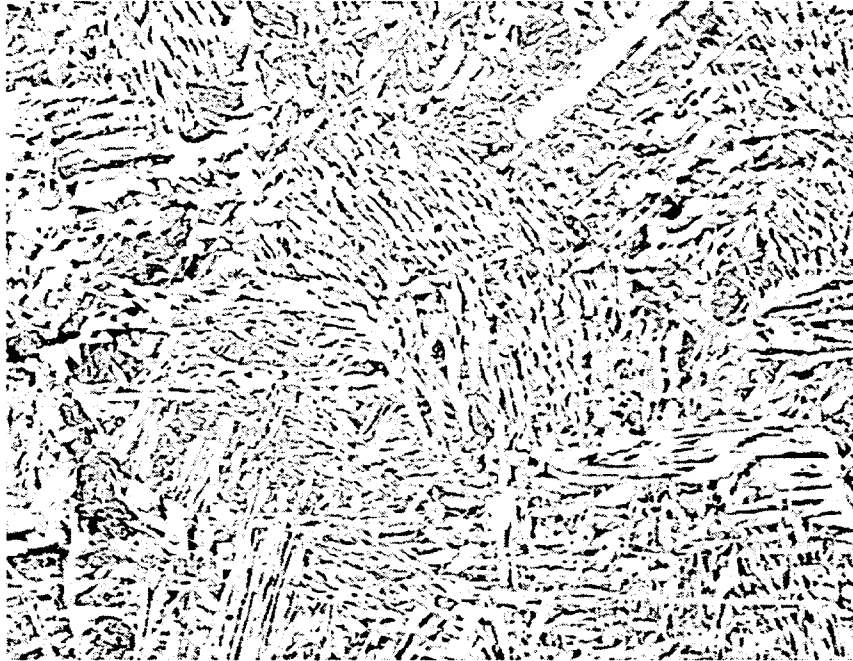
portions immediately adjacent to the weld and near the surface (where very high temperatures resulted in very large austenite grains) transformed to a microstructure of Widmanstatten ferrite and pearlite (Figure 4-3). The Widmanstatten structure is a fine needle-like microstructure, as opposed to equiaxed grains of mixed ferrite and pearlite (compare Figures 4-3 and 4-9). It is a geometric microstructure that results from formation of a new phase along certain crystallographic planes of the parent solid solution phase. The Widmanstatten structure can form in many alloys with certain heat treatments or cooling rates. A few hardness measurements indicated that the heat affected zone was slightly harder than the base metal, 92.8 Rockwell B, because of its finer microstructure.

Figure 4-3. Widmanstatten ferrite and pearlite microstructure seen in hottest regions of SGV480 heat affected zone, 400 \times .

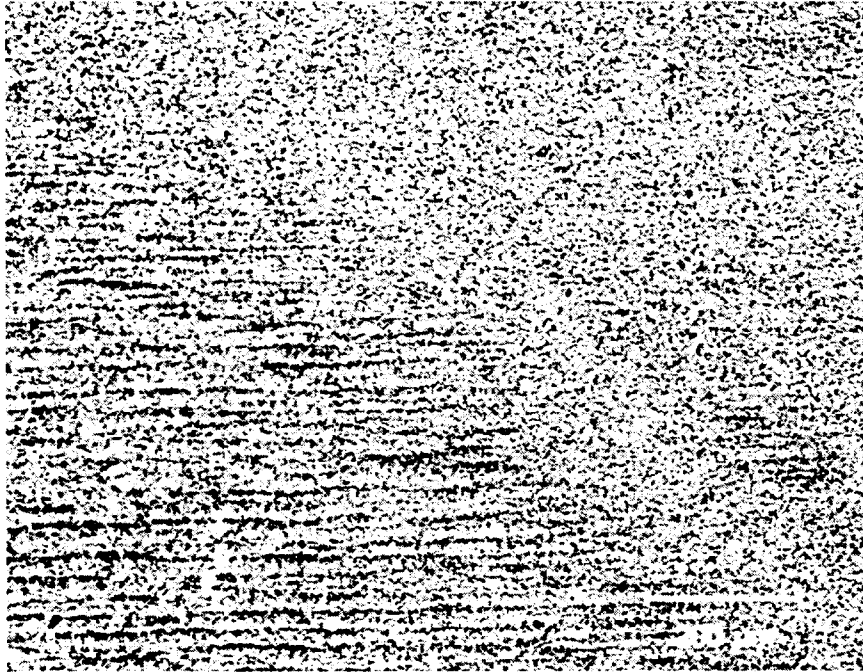
When welded, a much different microstructure develops in the reaustenitized heat affected zone. At 100× this microstructure appears significantly banded, indicating a pattern of chemical segregation that was not apparent in the martensitic/bainitic base metal (Figure 4-5). Higher magnification examination reveals the presence of a small amount of pearlite in the darker etching bands, consistent with 0.1% carbon (Figure 4-6). The remainder of the microstructure appears to consist of ferrite grains. In some areas these are fairly equiaxed, while in others they are more elongated and plate-like, typical of Widmanstätten ferrite or low-carbon martensite/bainite (Figure 4-7).

Figure 4-5. Banded microstructure typical of SPV490 heat affected zone, 100×.

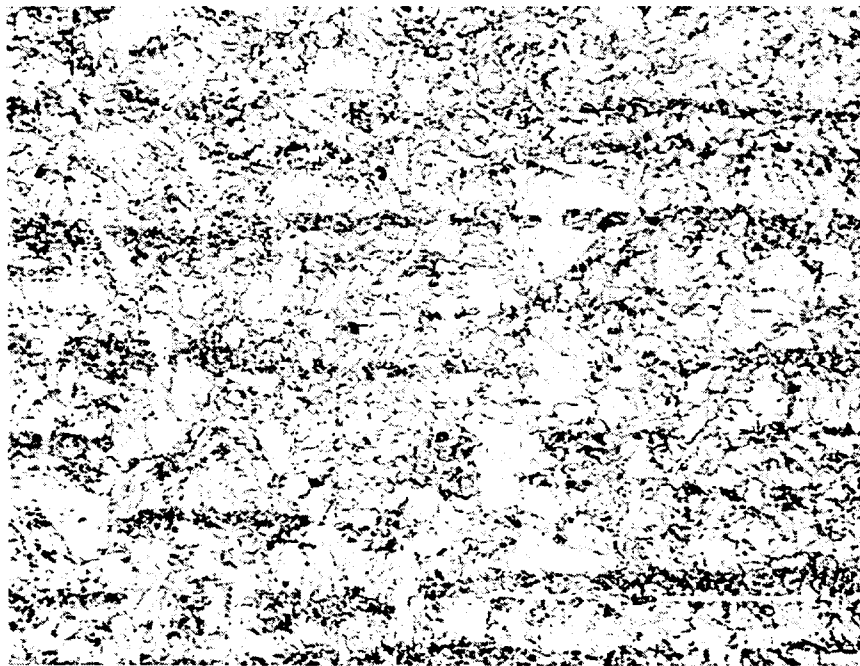
Figure 4-6. Ferrite and pearlite microstructure typical of SPV490 heat affected zone, 400×.

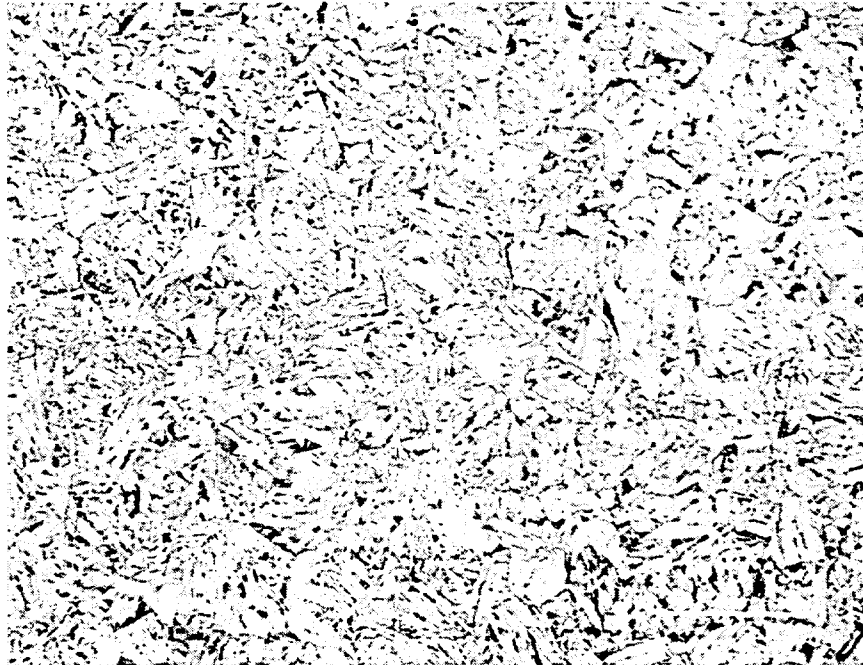
Figure 4-7. Widmanstatten ferrite or low-carbon martensite/bainite microstructure seen in some areas of SPV490 heat affected zone, 400 \times .

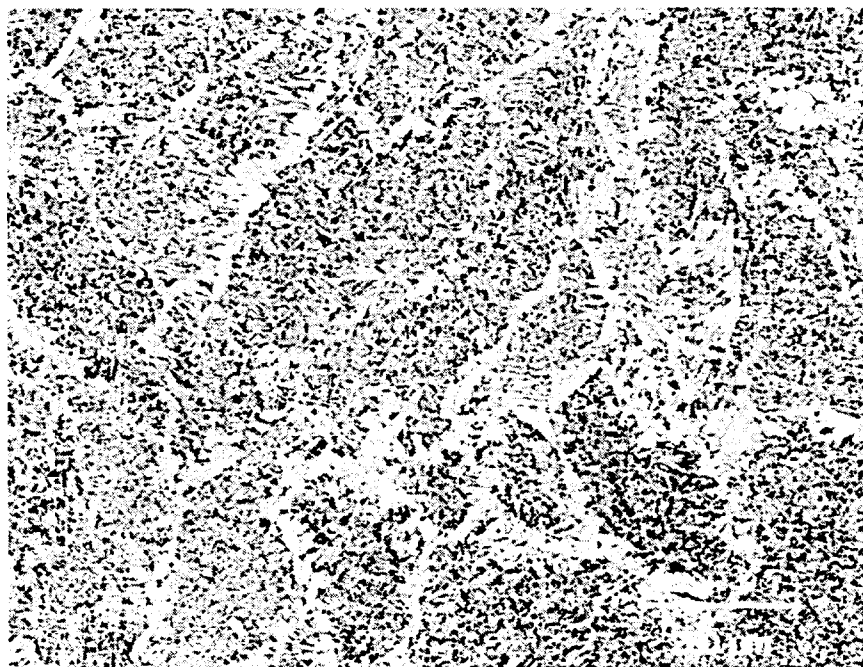
transformed to Widmanstätten ferrite and pearlite (Figure 4-8). The underlying prior fusion zones had been altered/transformed during subsequent weld passes, and consisted of much finer equiaxed ferrite grains and pearlite colonies (Figure 4-9). The hardness of the fusion zones (Table 4-2) was found to average Rockwell B 95.6, with the final fusion regions being slightly harder (~97), and the altered earlier passes being slightly softer (~94). No significant weld defects were observed in any of the samples.

Figure 4-8. Widmanstatten ferrite and pearlite microstructure typical of last pass fusion zones in all samples, 100 \times .

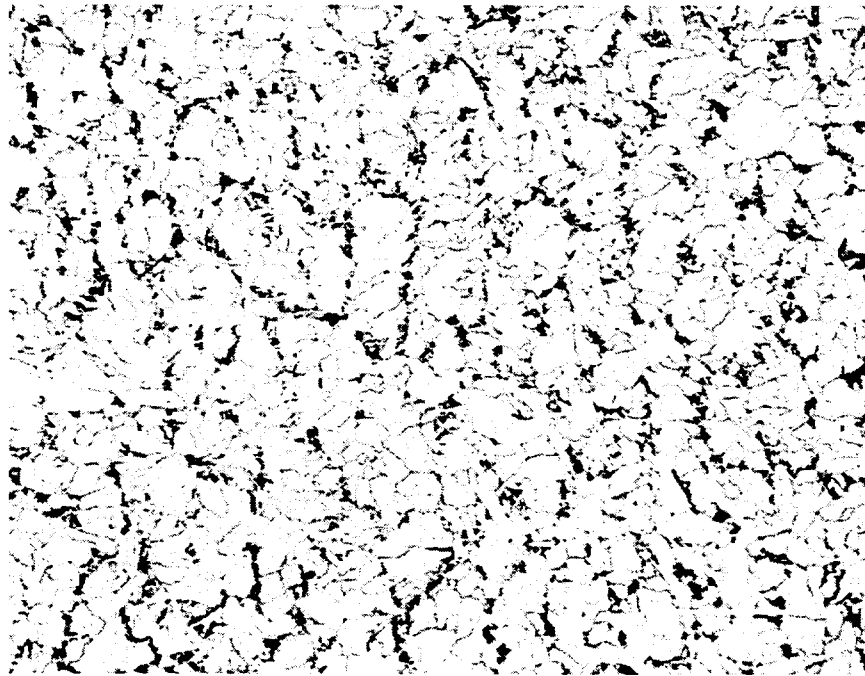
Figure 4-9. Equiaxed ferrite and pearlite microstructure typical of fusion zones altered by subsequent weld passes, 400 \times .
